## Fatalgrams and Fatal Reports

Fatality #18 - July 25, 2008
Fall of Roof or Back - Underground - Virginia
Consolidation Coal Company - Buchanan Mine #1

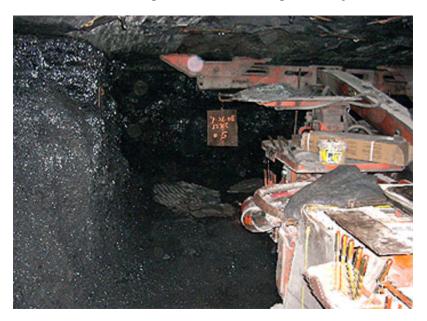
**COAL MINE FATALITY -** On July 25, 2008, a 44 year old roof bolter operator with 20 years mining experience was fatally injured while marking the location for roof bolts to be installed. Apparently the victim was between the drill station and the installed automated temporary roof support (ATRS) when a large piece of roof rock 55" long X 50"wide ranging from 4" to 6" thick fell. The rock knocked him into the roof bolting machine causing fatal injuries.

- When possible, stay under the roof bolter canopy when working in the area between the ATRS and the last row of permanent roof support.
- Incorporate proper use of roof bolter canopy extensions if provided.
- Examine the roof, face and ribs, including sound and vibrations tests, during pre-shift examinations, immediately before any work is started, and periodically as conditions warrant.
- Scale any loose or hazardous roof material using proper equipment and work from a safe location.
